# An Analysis of Nondestructive Evaluation Techniques for Polymer Matrix Composite Sandwich Materials

1. AGENCY USE ONLY (Leave blank)		2. REPORT DATE June 2006		3. REPORT TYPE AND DATES COVERED Technical Memorandum
4. TITLE AND SUBTITLE An Analysis of Nondestructive Evaluation Techniques for Polymer Matrix Composite Sandwich Materials			5. FUNDING NUMBERS  WBS 698259.02.07.03

9. SPONSORING/MONITORING AGENCY NAME(S) AND ADDRESS(ES) National Aeronautics and Space Administration Washington, DC 20546-0001			10. SPONSORING/MONITORING AGENCY REPORT NUMBER  NASA TM-2006-214349

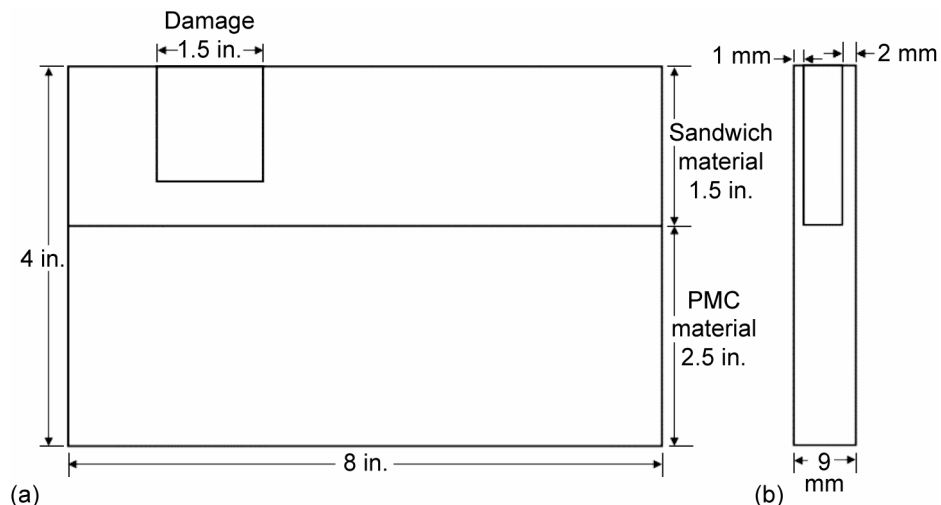
The flat panel used to investigate damage into the foam core had PMC face sheets and a foam core. The face sheets were 2 mm thick on the side closest to the foam damage and 1 mm thick on the side opposite the foam damage. Both face sheets consisted of a triaxially braided carbon fiber and epoxy laminate. The full thickness of the flat panel was constant at 9 mm. A schematic of the panel is shown in figure 3. The 1.5 in. wide edge of the panel consisting of the sandwich material was the region of interest in this study, while the bottom 2.5 in. consisted of the PMC material only. This panel was cut from a larger panel to reveal an exposed edge of the sandwich region in order to make a region of known damage. To simulate damage in the foam core, a knife was used to create planar damage in the core as shown in figures 3 and 4. A small amount of foam remained on the surface of the face sheet.

Figure 3.—Schematics of the flat panel with sandwich material depicting the locations of the sandwich material and the foam core damage. (a) Top view of the sample. (b) Side view of the sample.
